NASA TM X- 62,428

THE EFFECT OF A PLANETARY SURFACE PENETRATOR ON THE SOIL COLUMN  
SURROUNDING THE IMPACTING BODY

ABSTRACT

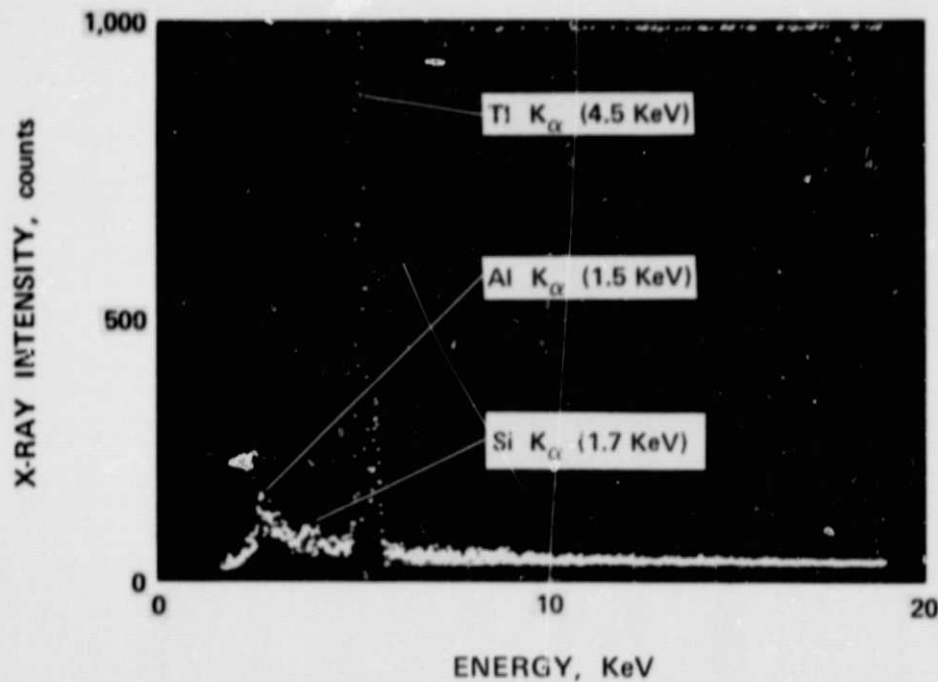
Chips of red and white paint, casing metal, and nose cone metal were removed from the penetrator using a silicon carbide scribe. The chips were analyzed for their elemental composition using an X-ray emission attachment on the scanning electron microscope. Figure 6(a) shows the composition of the white paint, and figure 6(b) shows the composition of the red paint. The primary difference between the two paints is the concentrations of titanium and sulfur. The white paint is high in titanium and the red paint is high in sulfur. The composition of the nose cone and casing body metal appear nearly identical, as shown in figure 7. Both are high in iron, with a trace of manganese. Soil samples adjacent to the penetrator housing were prepared for X-ray fluorescence analysis in two ways: one sample (inner surface) was soil adhering directly to the face of the penetrator casing; the second sample (outer surface) was soil 1.27 to 1.91 cm (0.5 to 0.75 in.) away from the penetrator's casing. Samples of both materials were carefully removed from the penetrator casing and placed in their respective X-ray sample holders. The two samples were then analyzed for their elemental composition using standard X-ray fluorescence techniques. The analytical results are shown in table 1. The X-ray fluorescence scans (fig. 8) show a definite peak for sulfur in low concentrations, along with a significant peak for titanium content of the inner soil. All values are qualitative and no figures can be given for percentage concentrations from these results. No apparent increase in iron was noted between the two surfaces.

(a) Identifies elements Al, Si, and Ti, which are in the pigment for the white paint.

Figure 6.— Photos of CRT display delineating the number of X-ray photons counted from the paint sample in 200 sec time and the energy of the emitted X-rays.

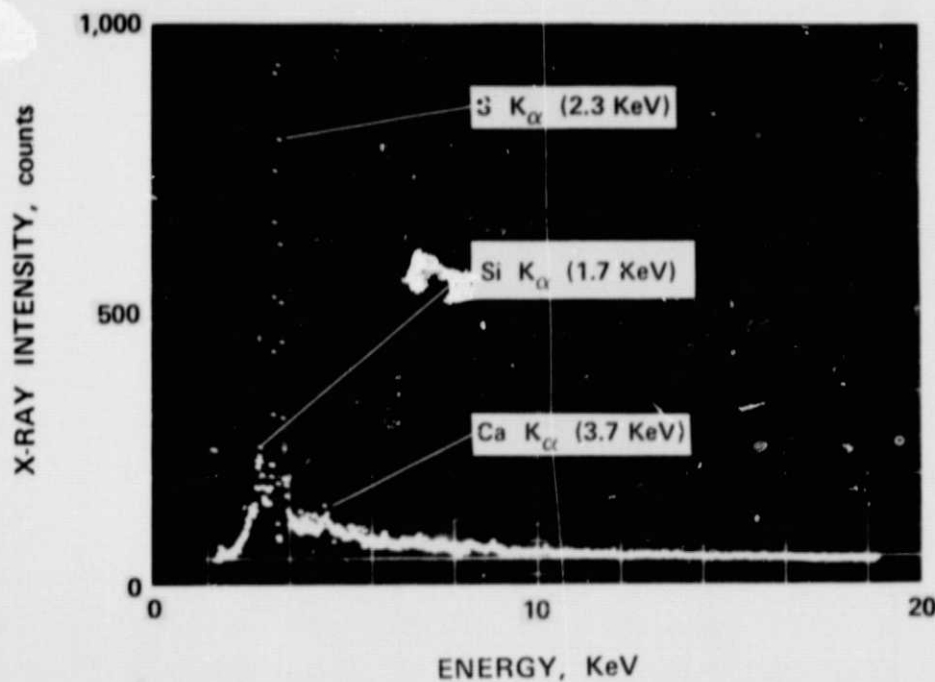
(b) Identifies elements Si, S, and Ca, which are in the pigment for the red paint.
